# Manhole Inspection Summary

Manhole # S41G\_\_008MH

Insp Date: **5/19/08 10:57 AM**

**Location** Address: **202 lloyd st**

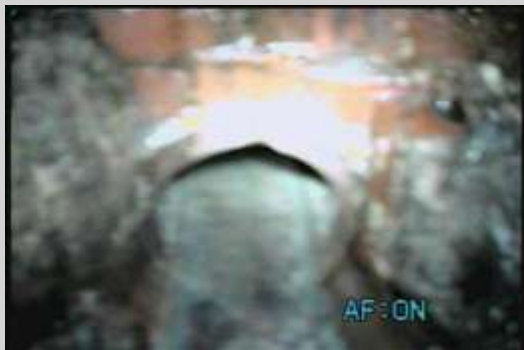
12 O'Clock Outflow

8 in. Circular Gravity Sewer  
Pipe Out @ 12 O'Clock

Pipe Material: **Clay** ☐ Pipe Lined

Invert Depth: **11.08** (ft.) Flow Characteristics: **Fast**

Infiltration: **None** Pipe Seal Cond: **Unknown**

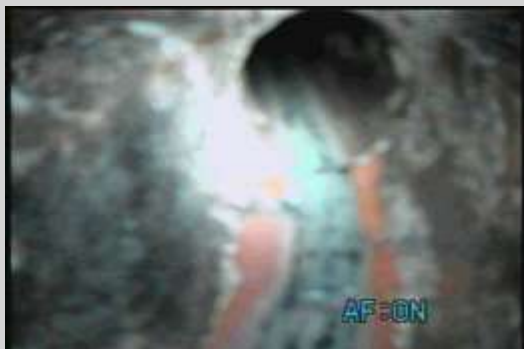
3 O'Clock Inflow

8 in. Circular Gravity Sewer  
Pipe In @ 3 O'Clock

Pipe Material: **Clay** ☐ Pipe Lined

Invert Depth: **10.95** (ft.) Flow Characteristics: **Fast**

Infiltration: **None** Pipe Seal Cond: **Unknown**

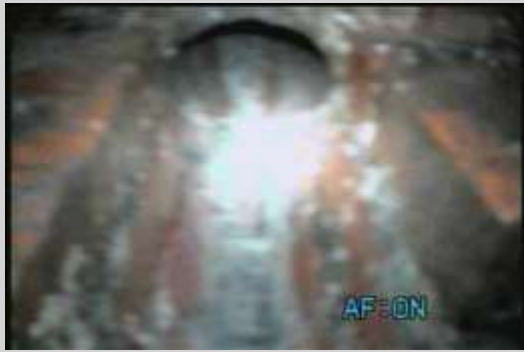
6 O'Clock Inflow

8 in. Circular Gravity Sewer

Pipe In @ 6 O'Clock

Pipe Material: **Clay** ☐ Pipe Lined

Invert Depth: **10.79** (ft.) Flow Characteristics: **Fast**

Infiltration: **None** Pipe Seal Cond: **Unknown**

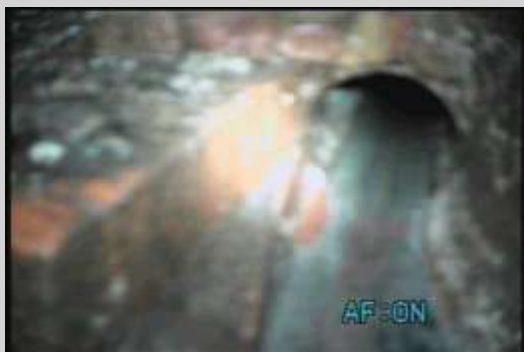
9 O'Clock Inflow

8 in. Circular Gravity Sewer

Pipe In @ 9 O'Clock

Pipe Material: **Clay** ☐ Pipe Lined

Infiltration: **None** Pipe Seal Cond: **Unknown**
